# 航空公司安全管理經驗分享

tigerair  
台灣虎航

TTW SQ Office  
雷治中

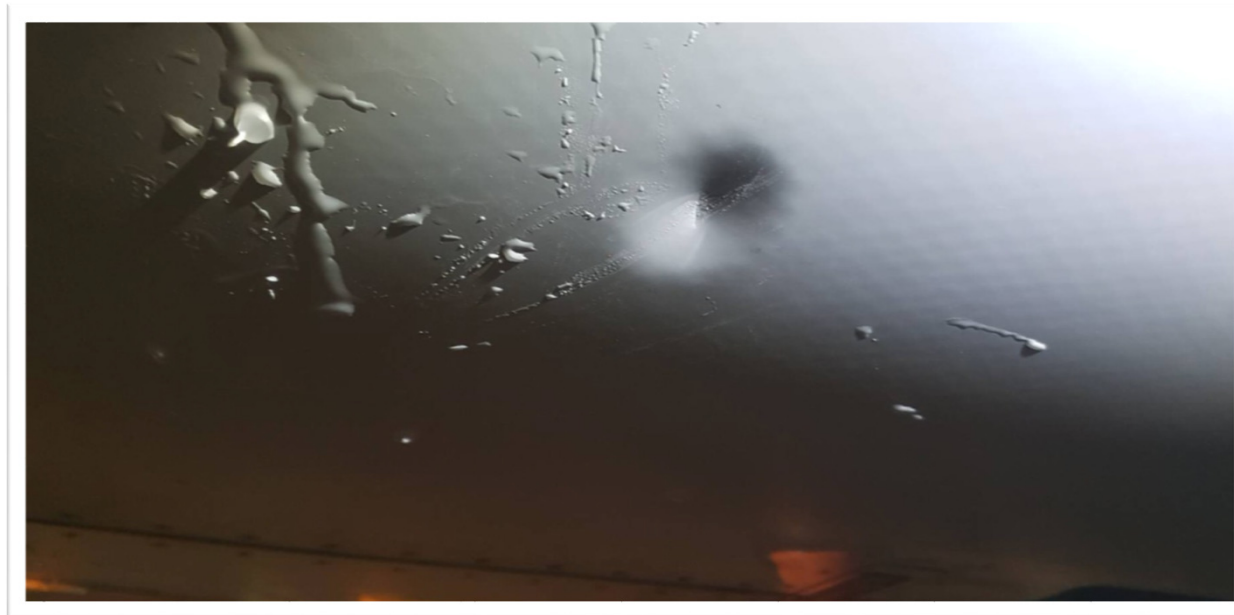
- There is one GDI incident that fueling staff dragged the fuel pipe through under R engine and the hook of the pipe hit the lower edge of engine cowling causing damage and AOG.

- Ground engineer please monitor fueling operation, fuel truck shall be parked parallel to the aircraft for immediate evacuation and the fuel pipe shall not pass underneath the engine.
- Load Supervisor or Ramp Coordinator please assist to monitor and coordinate the fuel operation, jointly defend ramp safety.

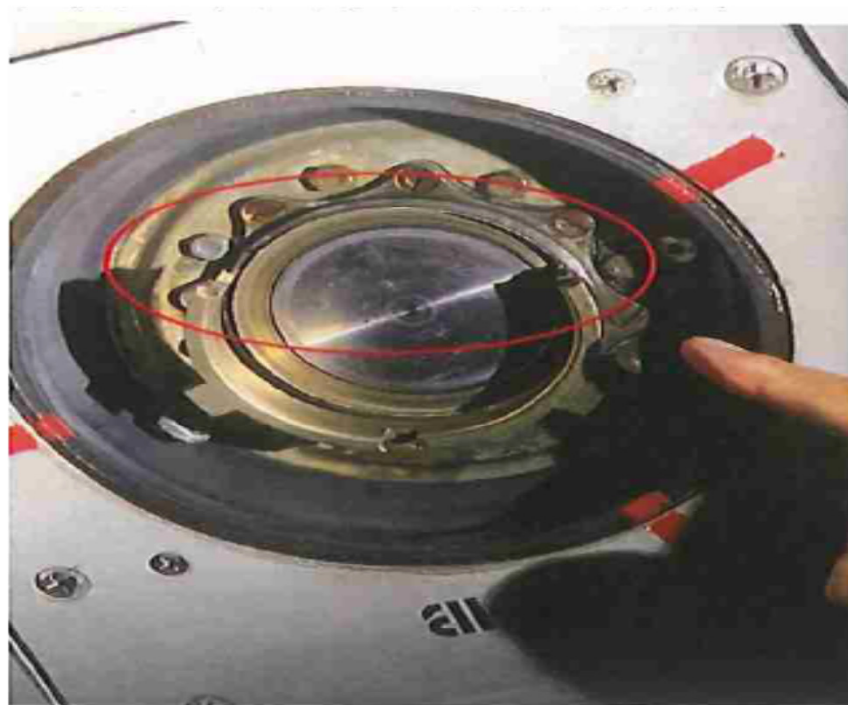
飛機加油口受損情形

(一)直接原因：飛機加油口受損造成漏油。

(1)執行加油作業未遵守加油標準作業程序(SOP)順序，且未將加油管先行拆下後再移動車輛。

(2)在煞車連鎖(INTERLOCK)鎖定下，加油員未經報備領班，擅自解除煞車連鎖(INTERLOCK)移動車輛。

油栓車停放位置不佳，造成油栓車進油口與機坪油栓口距離過長無法連接。

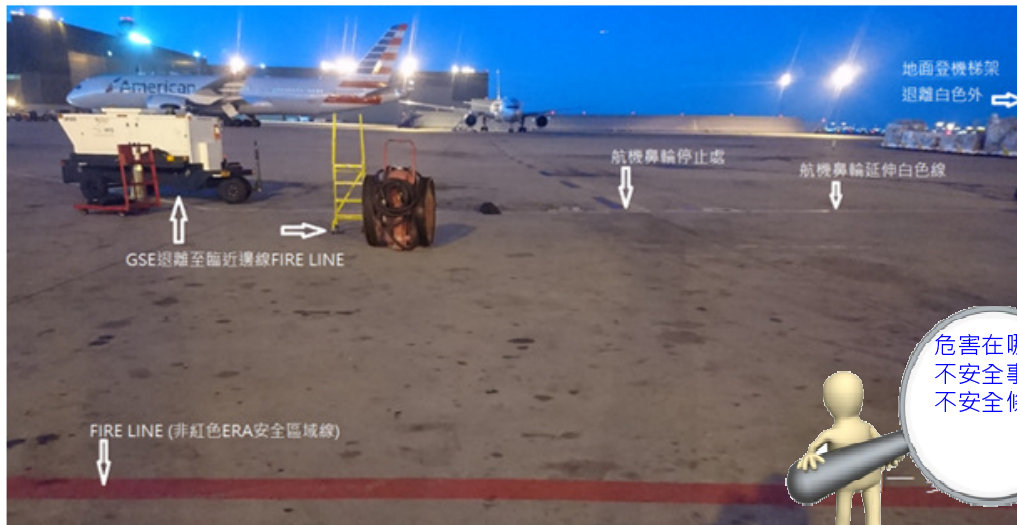
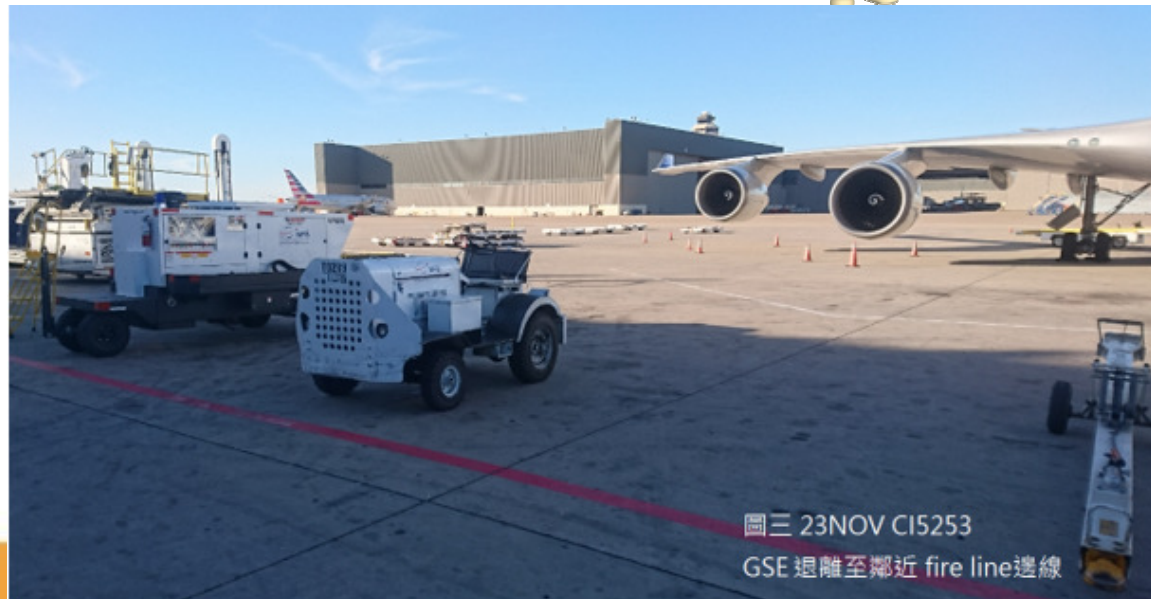
## 達拉斯貨機坪(DFW Apron) 無畫設 ERA Marking

地面裝備 GSE 淨空不足

風險管控：

1. 場面 fod 檢查；
2. 將 GSE 退至消防車道(fire line)邊線，以保持最大場面淨空安全區域，以確保航機進坪運行安全。

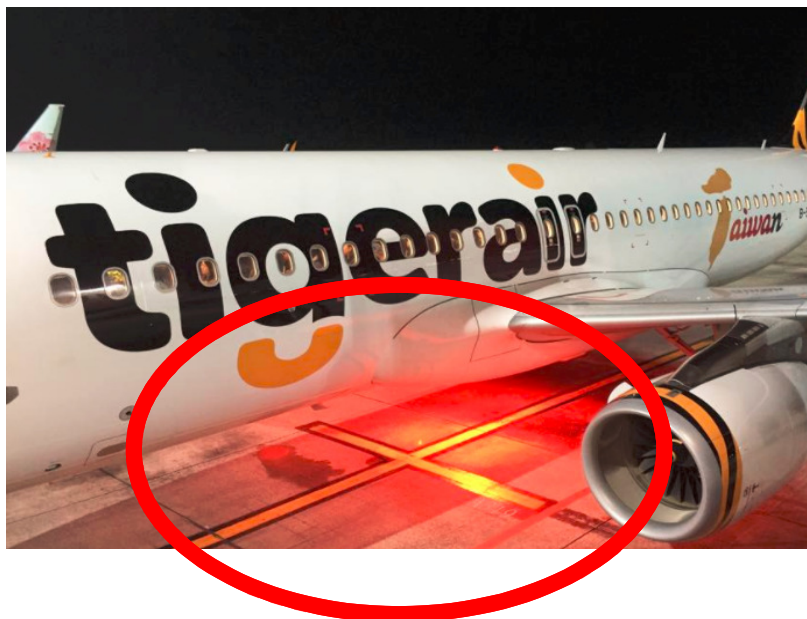
## Anti-collision Light

- An aircraft with its engine running will display a flashing red light signal known as an anti-collision light.
- The aircraft anti-collision lights are used as a danger warning to all ground staffs.

- Ramp staff (not involved in marshalling duties) and equipment approach an aircraft **MUST be waited until the anti-collision lights switched off.**
